REPORT OF RCRA COMPLIANCE INSPECTION

GENERAL MOTORS CORPORATION - GM ASSEMBLY DIVISION - LEEDS PLANT  
KANSAS CITY, MISSOURI

EPA ID NUMBER: MOD000822668

THE U.S. ENVIRONMENTAL PROTECTION AGENCY  
REGION VII  
SURVEILLANCE AND ANALYSIS DIVISION

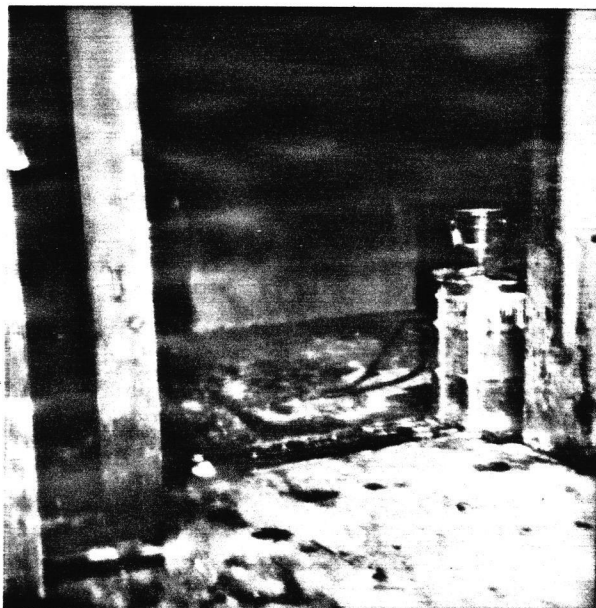
PHOTO NO. 1

Corrosives (D002) - The facility has two uncovered rectangular tanks containing caustic soda used in miscellaneous paint stripping operations. The tanks are located in a separate building in the shipping area west of the main assembly plant (see attached map). Spent caustic soda has not been shipped off-site since enactment of RCRA regulations. The capacity of the tanks is reported as 13,247 pounds. At the present time, plant officials have no specific plans on how or where the caustic waste will be disposed of. This situation will be resolved when it becomes necessary to ship excess caustic waste off site for disposal.

Caustic soda storage tanks

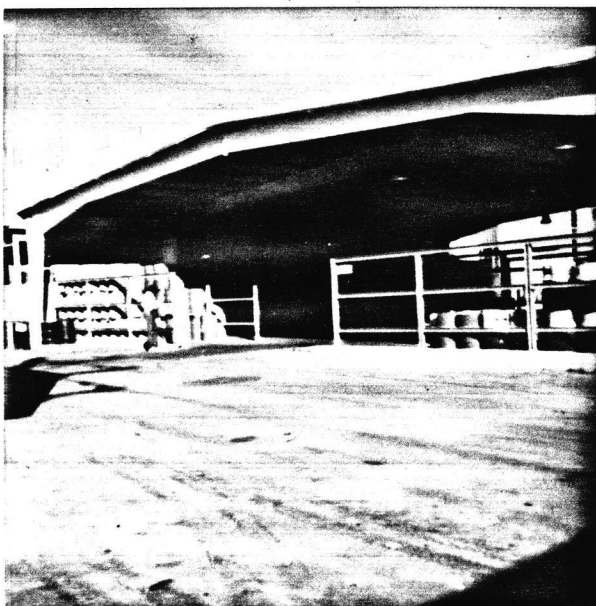
PHOTO NO. 2

The drum storage area, under canopy, contained three types of drums: drum shipments received from manufacturers, empty drums to be returned to manufacturers, and drums containing hazardous and non-hazardous waste material scheduled for disposal. In general, the drum storage area appeared to be in good shape. A few drums containing waste material were rusting, but the corrosion did not appear severe and the structural integrity of the drums did not appear compromised. Many of the waste containing drums were not labeled. Several bung-type drums were not sealed properly. It was not possible to determine by labeling whether the drums contained hazardous (waste solvent) or non-hazardous material (off-spec product). It is possible that company employees are able to identify the contents of these drums by stencil codes, but, again, inventory records were not available for review to confirm this.

Drum storage canopy; outgoing (empty) drums on left; incoming drum shipments on right; waste storage drums behind empty drums (not shown)

5. Stockpiled drums containing hazardous and non-hazardous material were not clearly labeled. As indicated in item No. 2, a written inventory of stockpiled drums was not available for review. If an accurate inventory of stored hazardous waste drums is not routinely kept, then individual drums should be properly sealed and labeled in accordance with 40 CFR 262.3-262.32.

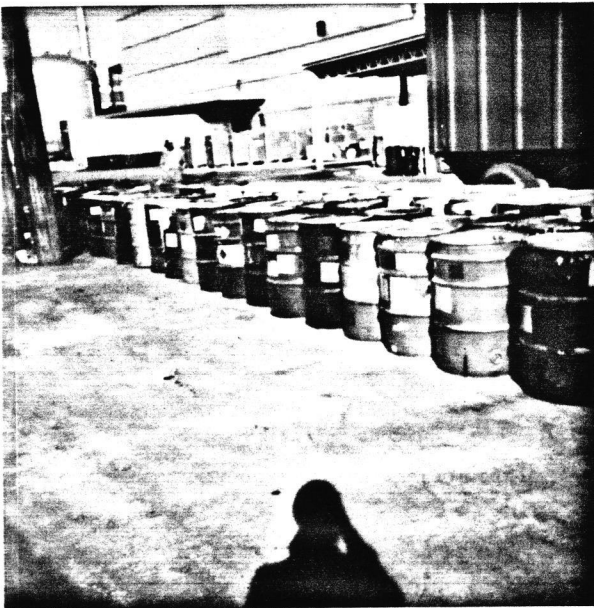
PHOTO NO. 3

GM officials reported that the cancelled shipment of drums had been sitting in the present location for approximately seven to ten days. These drums contained ignitable waste solvents and were sitting approximately three to 15 feet from the facility's property line in apparent violation of 40 CFR 265.176. It appeared, however, that this was only a temporary situation which would be rectified when either the drums were shipped or returned to the canopy storage area.

Hazardous waste drums awaiting shipment; properly labeled, located within 50 meters of property line

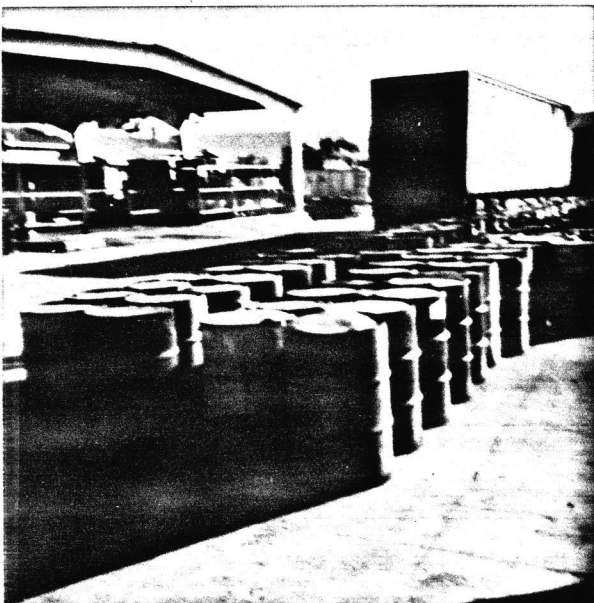
PHOTO NO. 4

At the time of the inspection a quantity of drums (approximately 153) were sitting by an empty trailer, some distance away from the drum storage canopy. These drums had been scheduled for shipment to a TSD facility, but the arrangements had recently been cancelled. As a result, the loading had not been completed. Inspection of these drums showed that not all drums were properly labeled as required by 40 CFR 262.30-32. Company officials stated that labeling was not completed because the scheduled shipment to the TSD facility had been cancelled. Also, in a subsequent telephone conversation, Mr. Pemberton stated that company workers had experienced difficulties with getting the proper labels to stick to the drums, so had temporarily reverted to a drum stenciling system, which identified the type of waste contained in the drums. Since this information was relayed by phone, it was not possible to personally verify the accuracy or acceptability of this identification system.

Hazardous waste drums awaiting shipment; not properly labeled, located within 50 meters of property line

3. Drums being prepared for shipments were not properly labeled, as required by 40 CFR 262.31 and 262.32. It is noted that pretransport preparation had not been completed when shipment plans were cancelled.

4. Ignitable wastes (waste solvents) were located within 15 meters of the facility's property line in violation of 40 CFR 265.176. It is noted that the location was likely temporary pending resolution of final shipment plans.

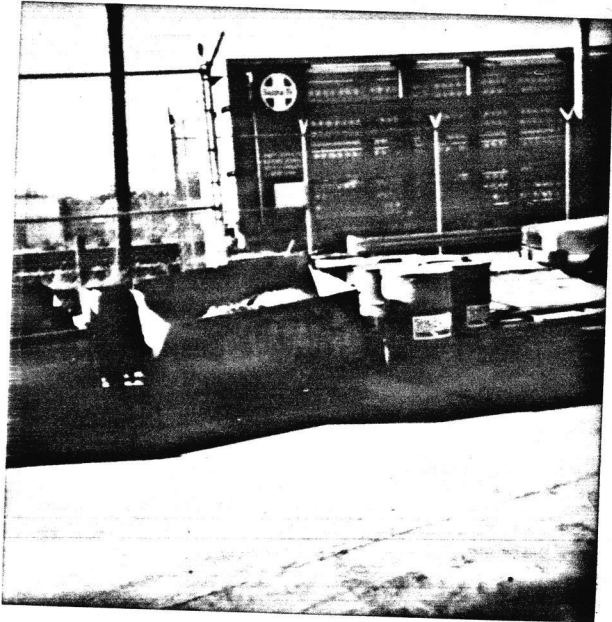
PHOTO NO. 5

Hazardous waste drums awaiting shipment; not properly labeled, located within 50 meters of property line

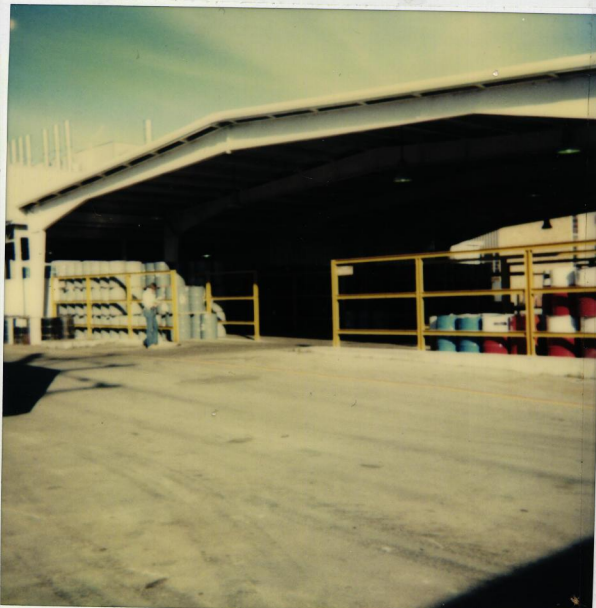
PHOTO NO. 2

Drum storage canopy; outgoing (empty) drums on left; incoming drum shipments on right; waste storage drums behind empty drums (not shown).

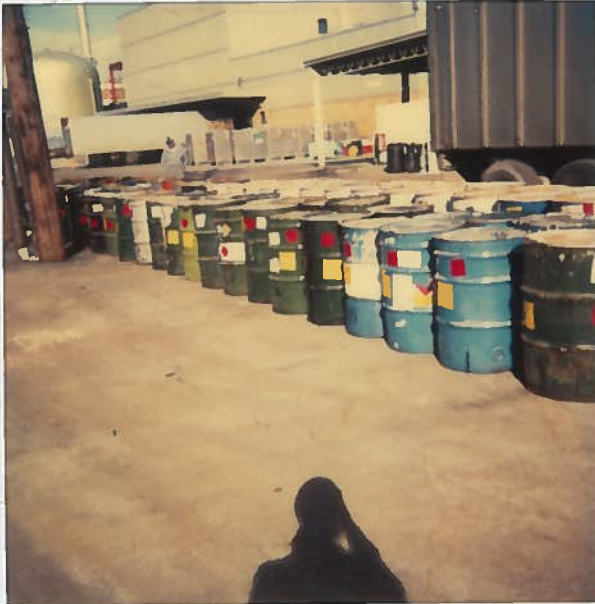
PHOTO NO. 3

Hazardous waste drums awaiting shipment; properly labeled, located within 50 meters of property line.

Direction of View: Northeast

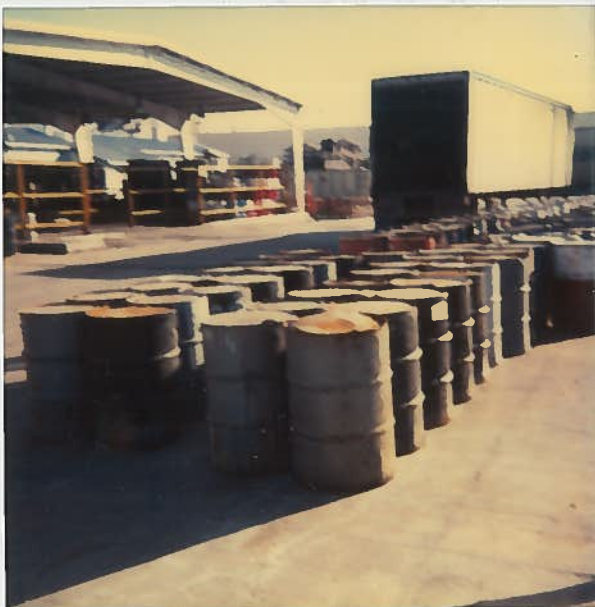
PHOTO NO. 4

Hazardous waste drums awaiting shipment; not properly labeled, located within 50 meters of property line.

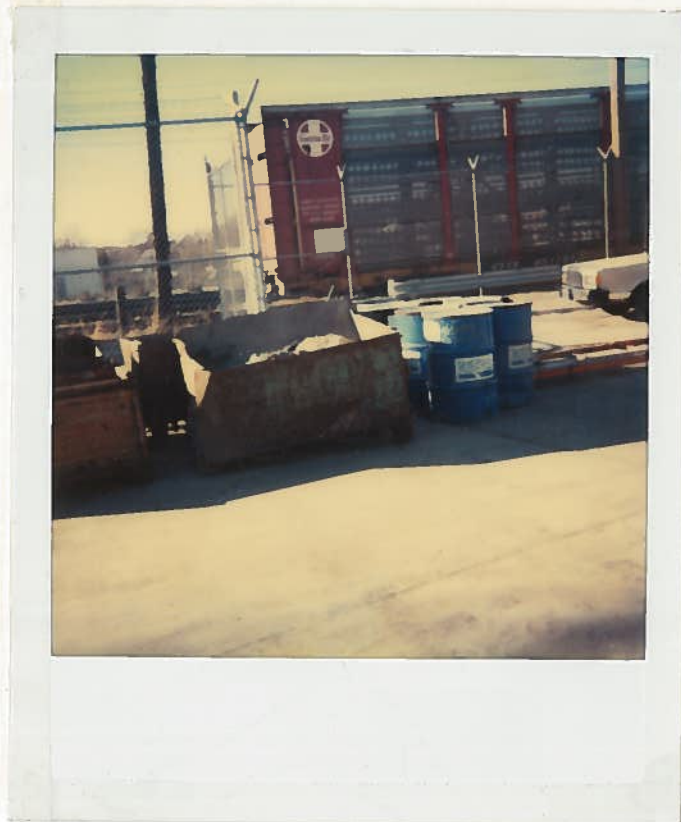
PHOTO NO. 5

Hazardous waste drums awaiting shipment; not properly labeled, located within 50 meters of property line.
